Machine shop motor failures

Application Note

Power Quality Case Study

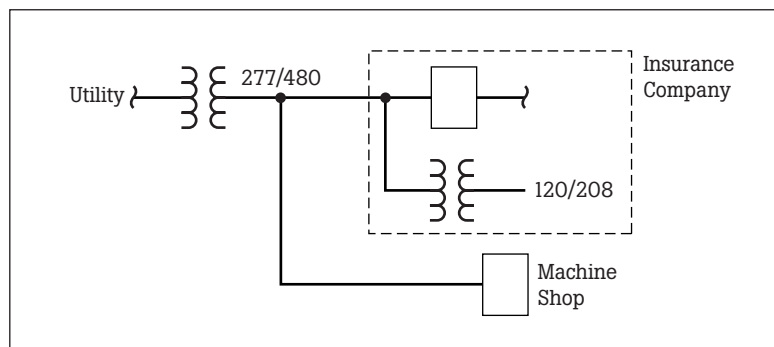
The machine shop itself hadn't undergone any changes. But an insurance company had moved into a new building next door. And they had done so at about the time when the motor failures began. The same utility transformer supplied both buildings (see Fig. 1).

Fig. 1 Utility connections for the machine shop and insurance company

In the case of the machine shop, non-linear loads in the neighboring insurance building caused 5th harmonic distortion on the supply voltage. Computer and office machine loads connected to the 120 V receptacles were generating 3rd, 5th, 7th, 9th, and 11th harmonic currents. When these currents reached the 120/208 V transformer, the balanced portion of the zero sequence harmonics (e.g., 3rd, 9th) were trapped in the delta primary but the 5th, 7th, and 11th passed through. These reached the secondary of the utility transformer, where they caused the voltage distortion measured at the machine shop service.

The utility, when notified about the voltage distortion problem, agreed to install a separate transformer serving only the machine shop. The Fluke 43B showed voltage distortion on the new transformer was only 3.3 % — less than half of the previous value.
