Instant power replay solves a breaker trip

Application Note

Testing Functions Case Study

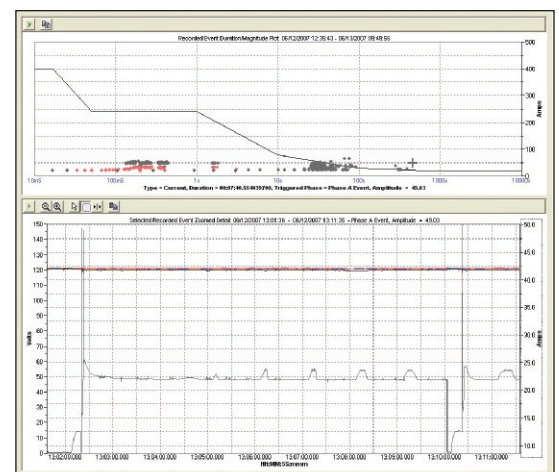
Figure 1. Current event view, top level events

The current event view shows several events outside the 20 A breaker tolerance curve. The longest event is shown in Figure 1.

The event exhibits a double initial current surge, followed by a sustained current over 20 amps. Although the circuit breaker did not trip during this event, its rating was exceeded and it would be likely to trip occasionally under similar conditions. These conditions are frequent during use of the temperature chamber, as can be seen in the graph above, where this event is immediately followed by another similar event whose beginning can be seen at the right side.

The power feed to the second floor is robust. The nuisance tripping is most certainly due to temporary overload of a standard 20 amp appliance branch circuit from using an industrial temperature chamber on the circuit. The temperature chamber should be connected to a dedicated branch circuit, sized to meet the requirements of the chamber, minimum 20 amps.

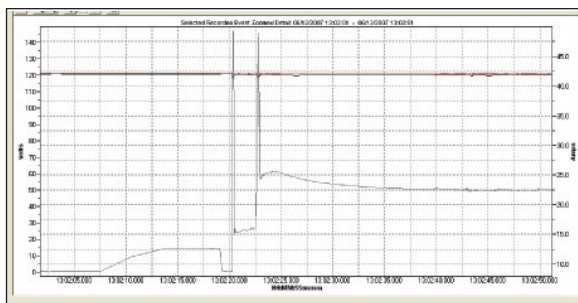
Figure 2. Compressor activity

Zooming into the initial region of the event in Figure 2, we see the turn-on loads of the temperature chamber's dual compressor system. The first compressor turns on with a large initial surge, followed by the secondary compressor surge. This load profile clearly identifies the temperature chamber as the cause of the overload.

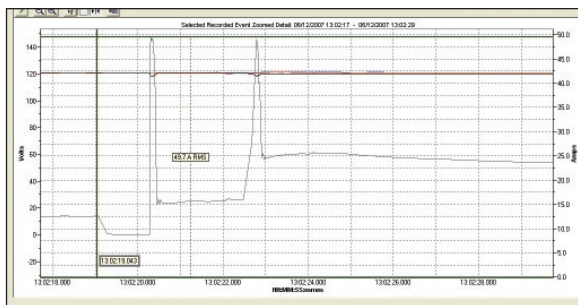
Figure 3. Load evaluation

Temperature chamber peak current is 49.7 amps. In Figure 3, the sustained load is near 25 amps.

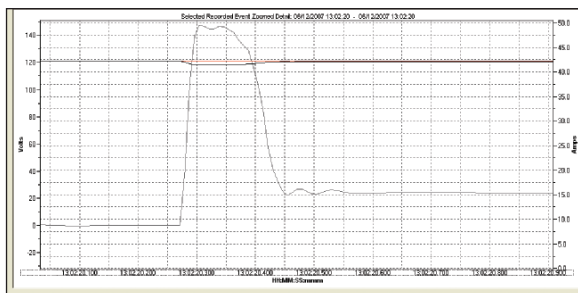
Figure 4. Interpreting voltage drop

We can zoom in further, in Figure 4, to see even more detailed resolution of this initial current surge. Note that the phase A voltage sags during this current surge, but the voltage drop is small, indicating that the power feed at the sub-panel is very stiff, and can accommodate substantial demand.
