Wound rotor problem detected with Megger Baker EXP4000 Without load

Motor nameplate: BBC Brown Boveri 400kW – 1485RPM

Case Study #1

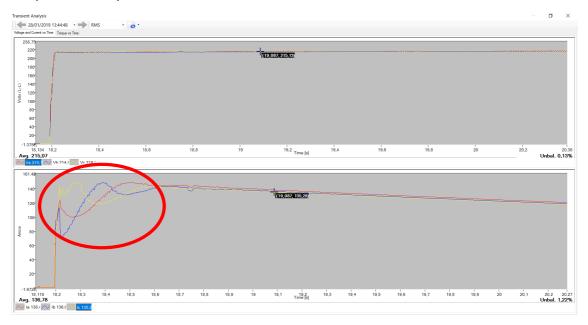
Dynamic analysis: Start up: During the startup the current is very unbalanced and during steady state the current is balanced. Voltage balance does not change through the start-up process. This phenomenon is due to contact resistance issue.

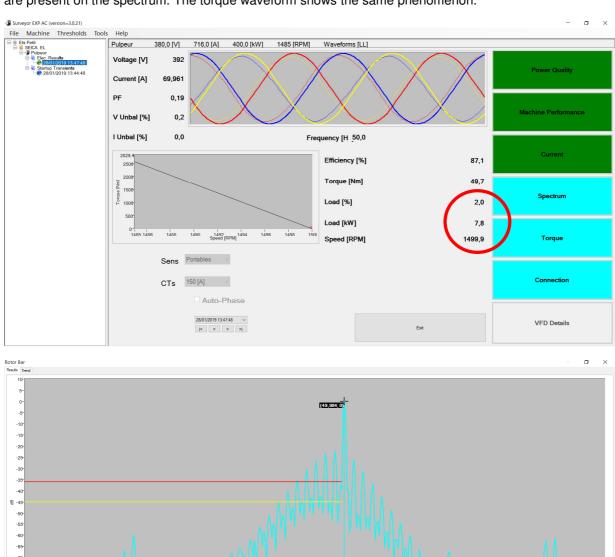
High level of modulation around the line frequency. The fundamental of the pole pass frequency is not visible in the spectrum due to the high shaft speed and the low load. But the harmonics of this frequency are present on the spectrum. The torque waveform shows the same phenomenon.

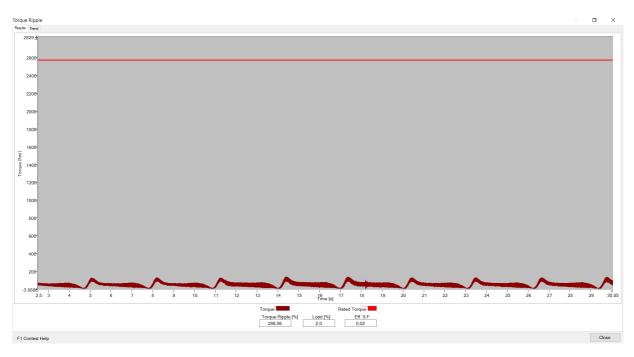
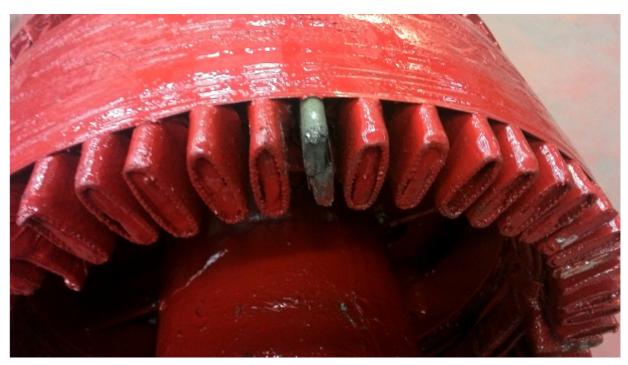
Defect located after removal of the insulation.

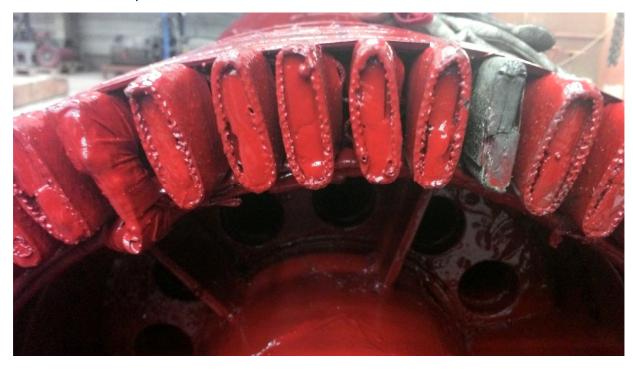
Contact resistance problem
