Motor Predictive Maintenance Test Technologies & Case Studies

Paul Knock

Megger Baker Instruments

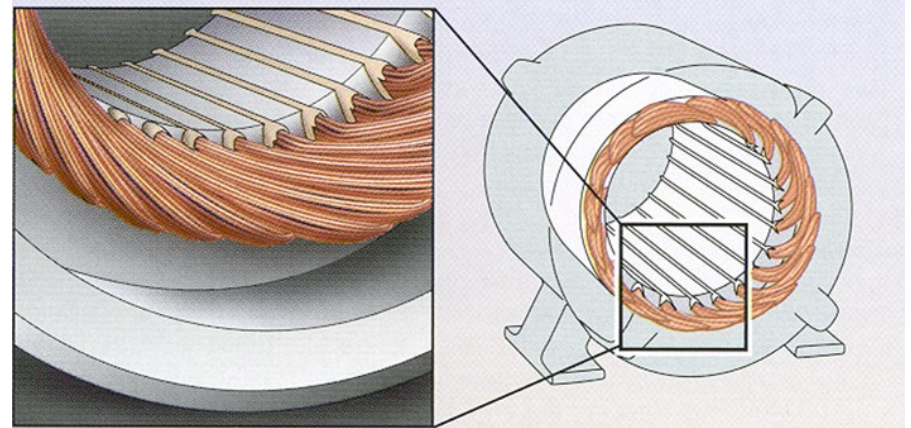
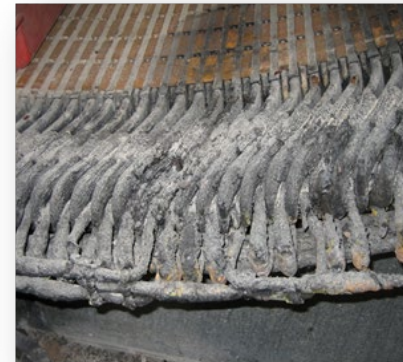
Service & Reporting – Static Motor Analysis

Results Summary		Test Date/Time 12/4/2008 10:25:16am	
Test ID:	415V W/Rotor	Repair/Job #	
Tested By	Paul Knock	Tested For	A Mann
Room #		MCC	Yes
Location	Main Drive	Building	
Temp Status	Tested	PI Status	PASS
Temp	20.0°C 68.0°F	Volts (V)	510
Resist Status	PASS	DA Ratio	2.7
L1-L2 (Ohms)	0.0275 Corr: 0.0280	PI Ratio	DA Only
L2-L3 (Ohms)	0.0276 Corr: 0.0282	Step-Voltage	MIN MEGOHM
L3-L1 (Ohms)	0.0276 Corr: 0.0282	Volts (V)	2000
Max Delta R %	0.533%	Current(μA)	423.00
Coil 1 (Ohms)	0.0138 Corr: 0.0140	Resist (Mohm)	5 At 40°C 1
Coil 2 (Ohms)	0.0137 Corr: 0.0140	Surge Status	ppEAR LIMIT
Coil 3 (Ohms)	0.0139 Corr: 0.0142	Peak Volt(V) L1	2000
Megohm Status	PASS	Peak Volt(V) L2	1240 Failed
Volts (V)	510	Peak Volt(V) L3	0
Current(μA)	4.10	Max P-P EAR%	6.8%,10.7%,--
Resist (Mohm)	124 At 40°C 31	EAR 1-2,2-3,3-1	30%,--,--

Comment:
Surge test failed at 1240V.
Turn to Turn insulation is showing deterioration.
Stepped High Voltage test also showed weak insulation to earth.

Action: Overhaul unit at next planned outage.

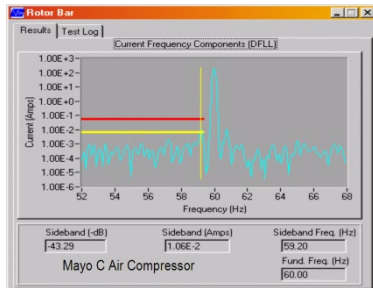
Rotor bar

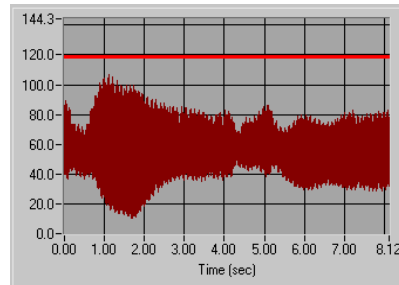
Instantaneous torque

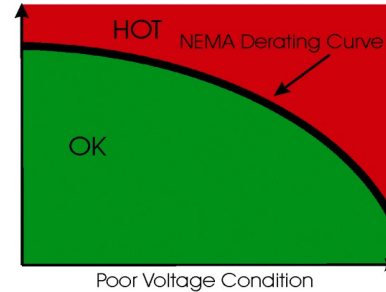
Thermal condition

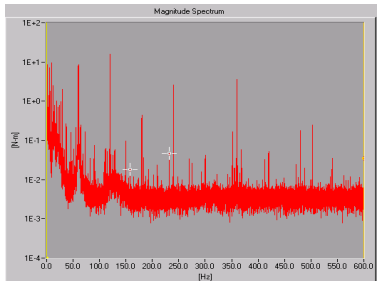
Voltage, current, and torque spectra

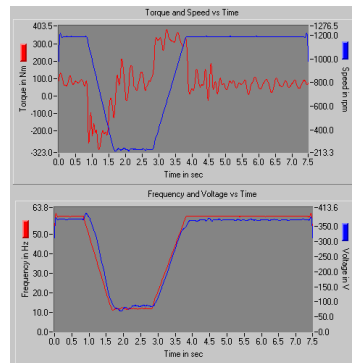
- VFD
- Torque vs. speed
- Freq. vs. voltage

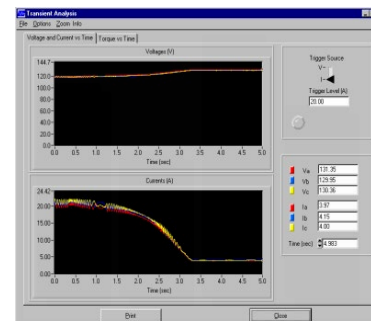
- Start-up transients
- Voltage, current, and torque over time

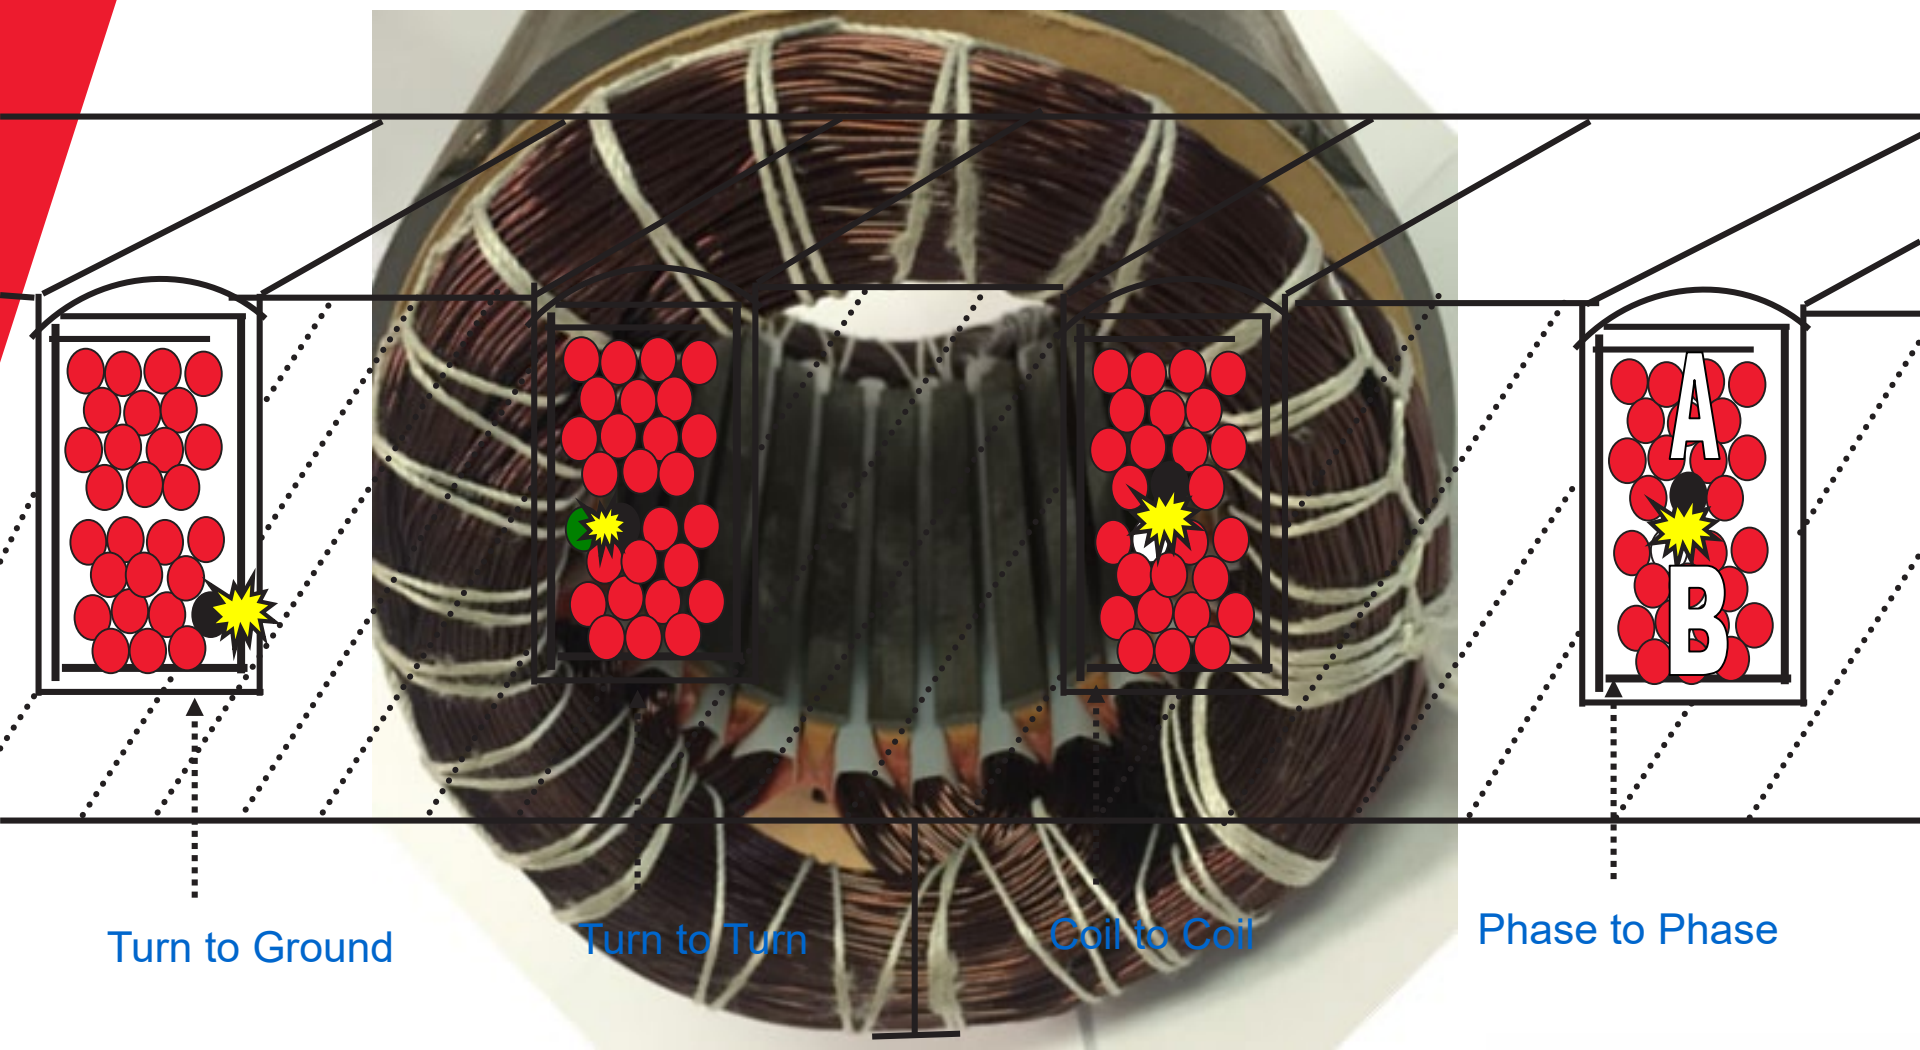
Stator Insulation Failure Modes

Turn to Ground

Turn to Turn

Coil to Coil

Phase to Phase

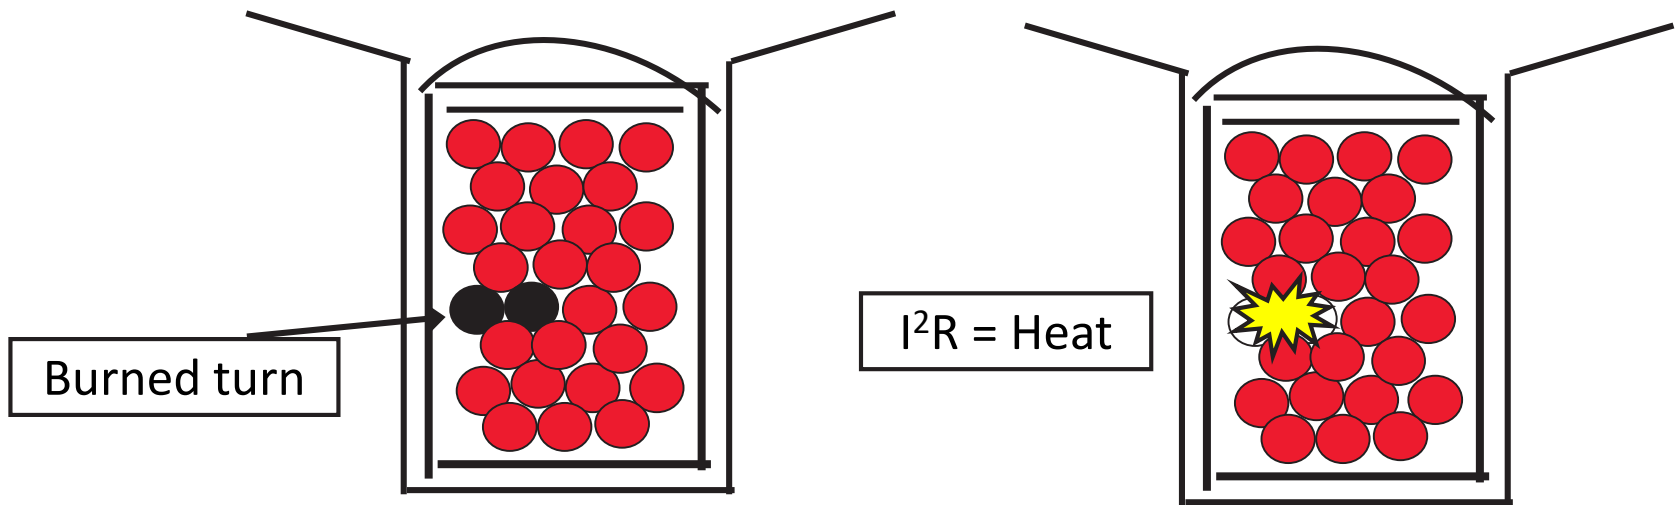
Fused Shorted Turns

- Initial shorting of the turns is often in the extension
- Failure to ground will be in the slots
- When the dielectric strength falls below the operating voltage the turns will fuse together

According to IEEE the welded faulted turns will burn through the slot cell liner to ground within 15 minutes.

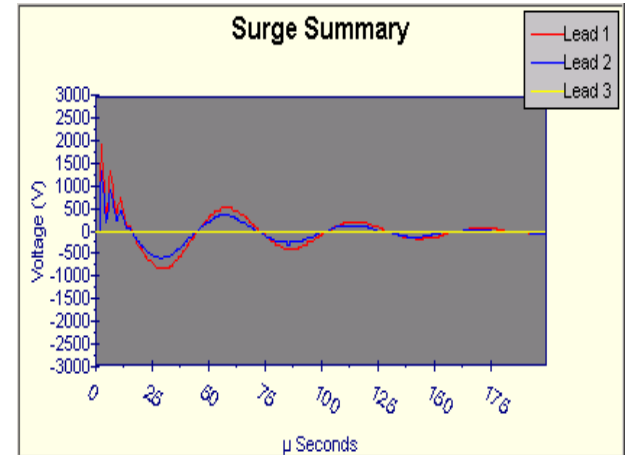
Service Work & Reporting – Motor Analysis

Results Summary		Test Date/Time 12/4/2008 10:25:16am	
Test ID:	415V W/Rotor	Repair/Job #	
Tested By	Paul Knock	Tested For	A Mann
Room #		MCC	Yes
Location	Main Drive	Building	
Temp Status	Tested	PI Status	PASS
Temp	20.0°C 68.0°F	Volts (V)	510
Resist Status	PASS	DA Ratio	2.7
L1-L2 (Ohms)	0.0275 Corr: 0.0280	PI Ratio	DA Only
L2-L3 (Ohms)	0.0276 Corr: 0.0282	Step-Voltage	MIN MEGOHM
L3-L1 (Ohms)	0.0276 Corr: 0.0282	Volts (V)	2000
Max Delta R %	0.533%	Current(μA)	423.00
Coil 1 (Ohms)	0.0138 Corr: 0.0140	Resist (Mohm)	5 At 40°C 1
Coil 2 (Ohms)	0.0137 Corr: 0.0140	Surge Status	ppEAR LIMIT
Coil 3 (Ohms)	0.0139 Corr: 0.0142	Peak Volt(V) L1	2000
Megohm Status	PASS	Peak Volt(V) L2	1240 Failed
Volts (V)	510	Peak Volt(V) L3	0
Current(μA)	4.10	Max P-P EAR%	6.8%,10.7%,--
Resist (Mohm)	124 At 40°C 31	EAR 1-2,2-3,3-1	30%,--,--

Surge test failed at 1240V.
Turn to Turn insulation is showing deterioration.
Stepped High Voltage test also showed weak insulation to earth.

Action: Overhaul unit at next planned outage.

Next Test: 1 Month

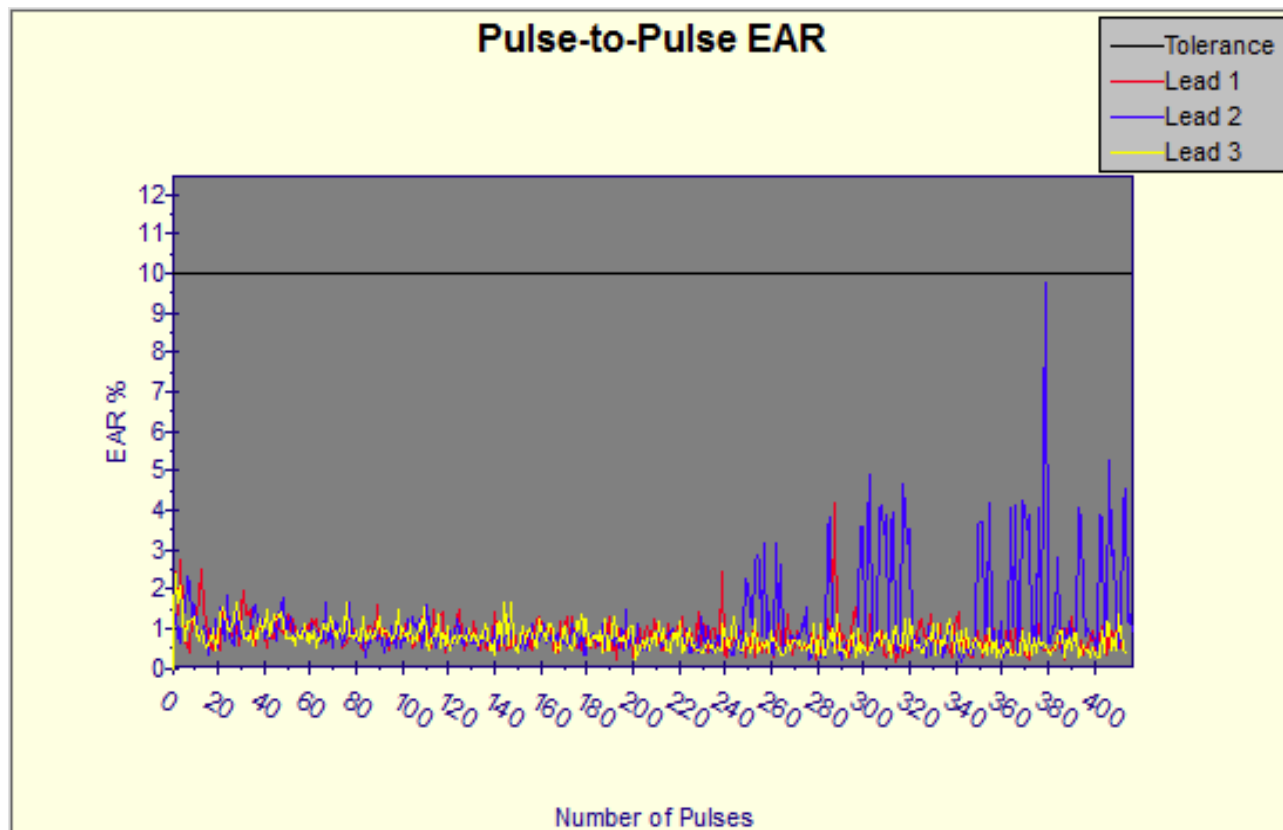
Case Study: 1 Cont'd

On looking at the initial test results the motor passed all test, but at closer inspection the Pulse to Pulse EAR is showing insulation breakdown.

The vessel had a scheduled dry dock and the motor was removed, when the motor was opened for a rewind and overhaul, there was a section of the motor where the insulation had started to breakdown. The motor was repaired within the scheduled dry dock period and the vessel is currently in service.

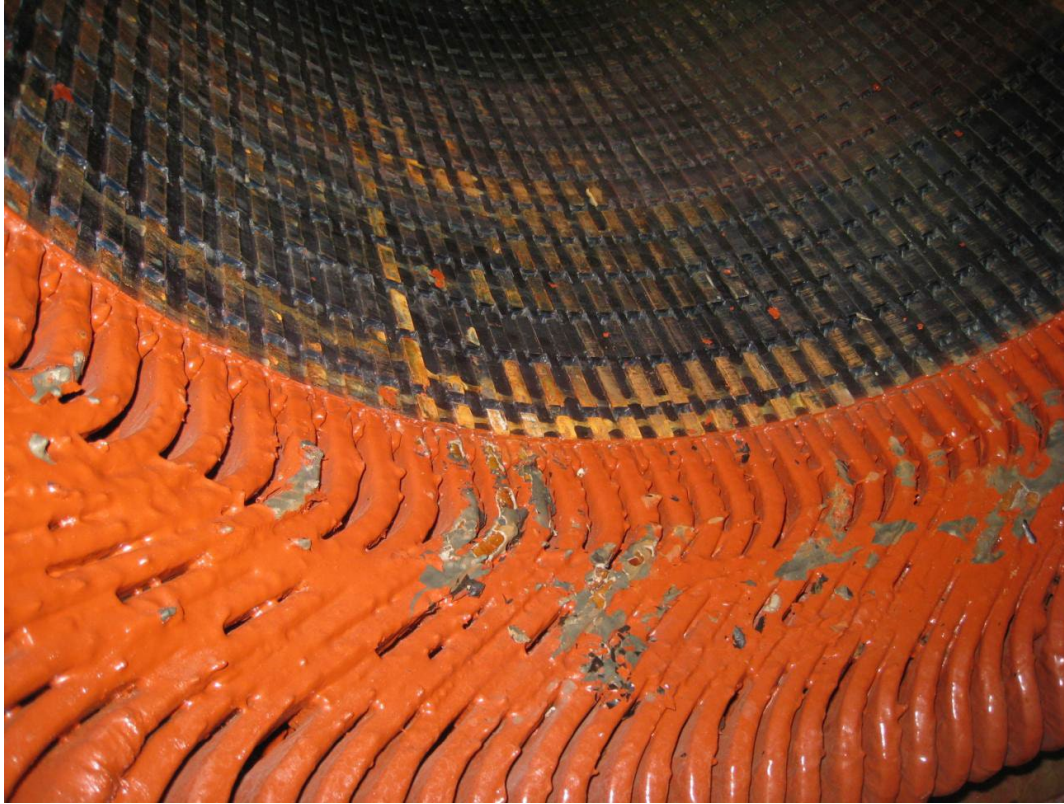
Findings After Dismantle

- 05/31/2012 My recommendation was to send to a motor repair facility for further analysis. The testing shows the Stator had Failed the “Surge Test”

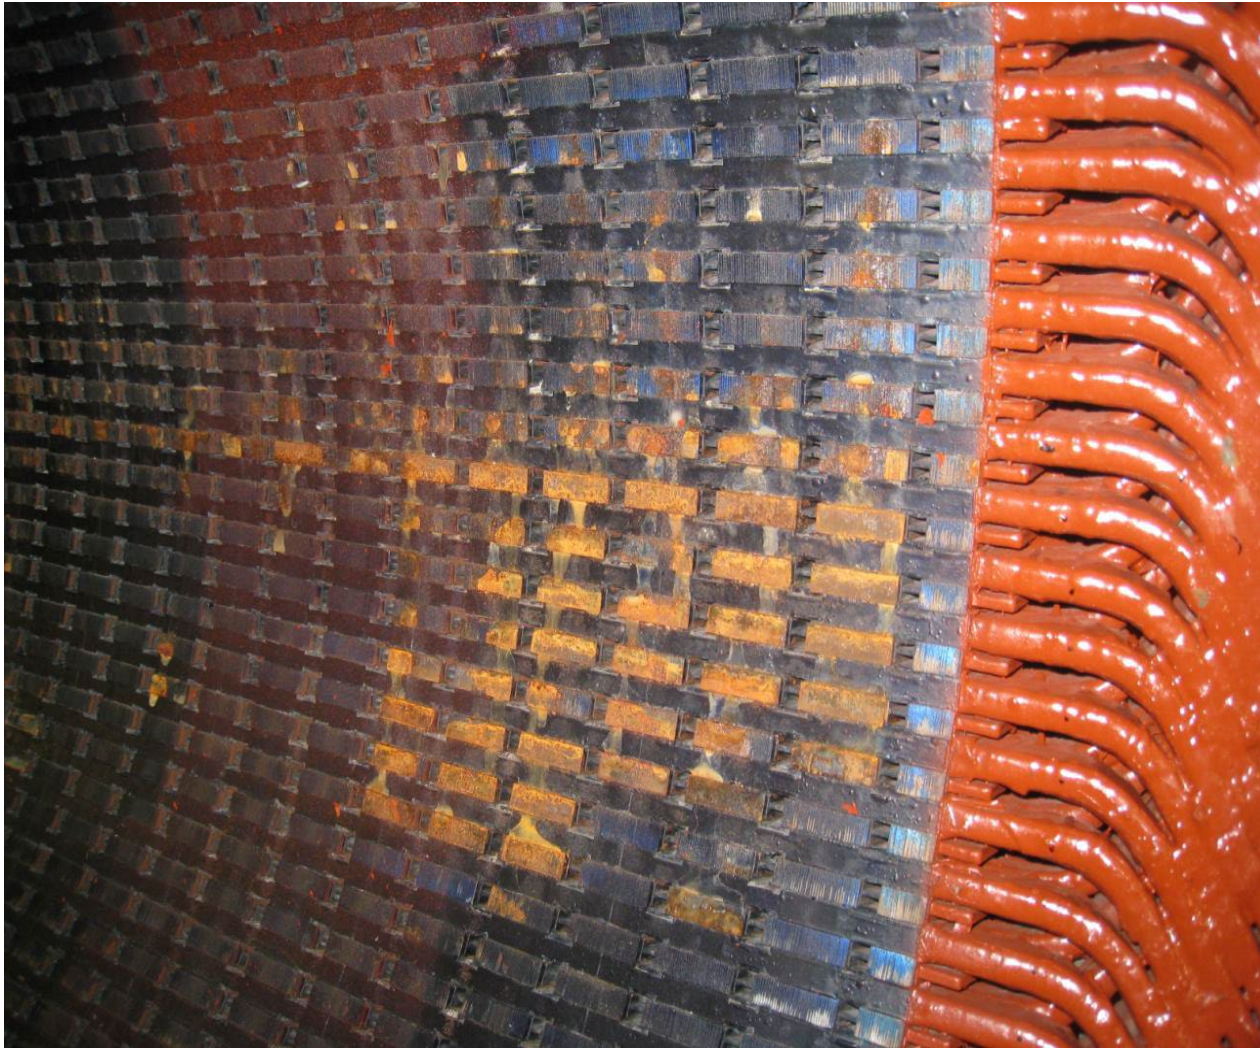
Stator Bore – signs of corrosion

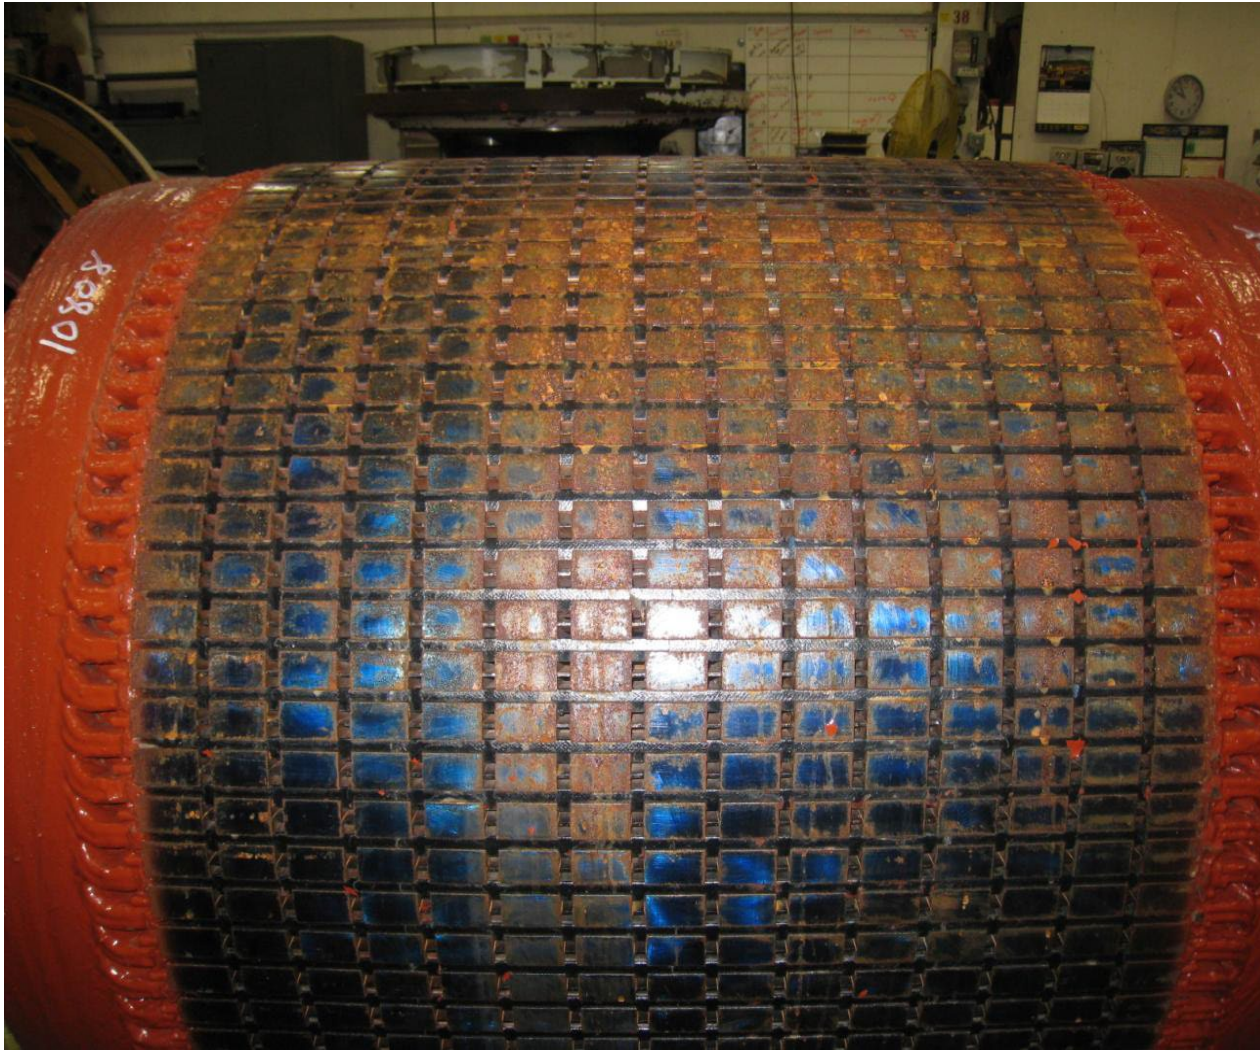
Rotor Condition

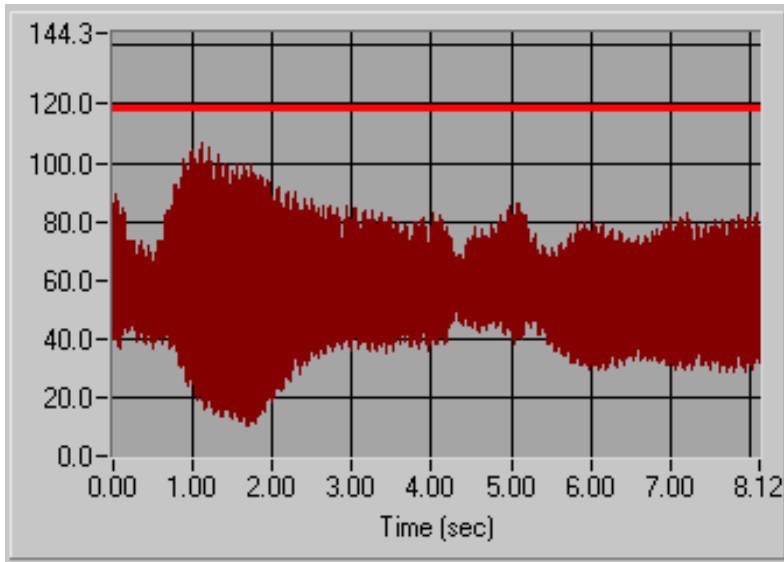
Pump # 1

- Problem found in the pump – not the motor:
 - First pump would only run at 28,000Nm
 - Pump showed fluctuating torque against time graph
- The utility wanted higher cooling capacity for summer months - pump pulled for repair Pump 1 Repair cost \$180,000
 - Saving \$ On Pumps 2 & 3 Repair & removal costs.

Torque Signature

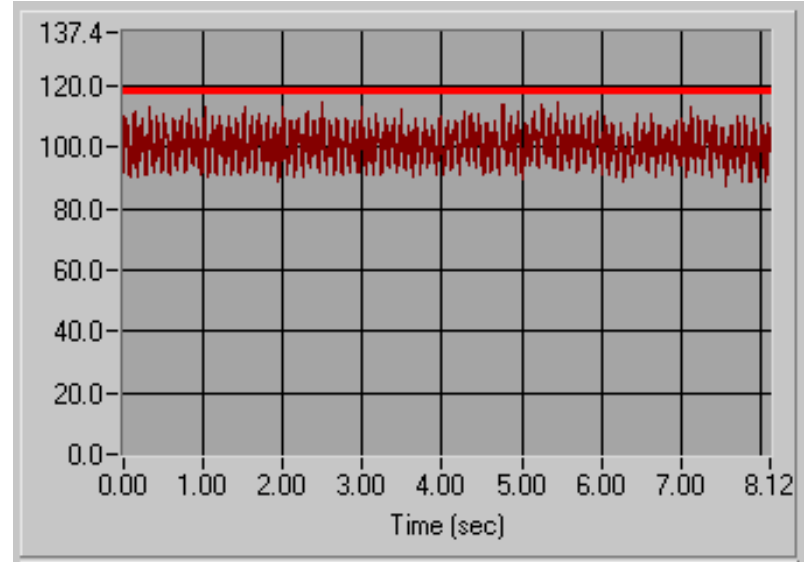
Typical - Pump # 2 & 3
