Elevator trips emergency generator breaker

Application Note

Power Quality Case Study

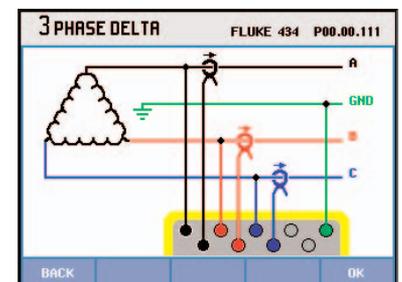
Facilities used a three-phase Power Quality Analyzer to examine the elevator system's operating characteristics during an emergency power system test. First, they connected the analyzer to the circuit and used the setup function to make sure all the connections were accurate.

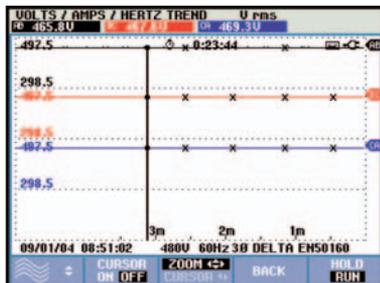
Looking at the trended Volts/ Amps/Hertz data, the technicians could see where the breaker tripped, but they didn't see any event data that would have caused it. This problem was too fast for regular readings.

All three phase voltages go to zero until the circuit breaker is reset.

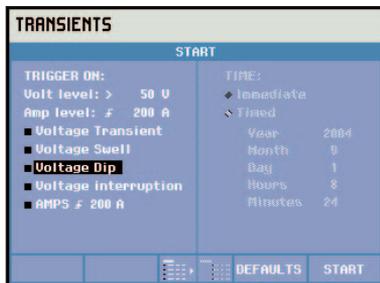
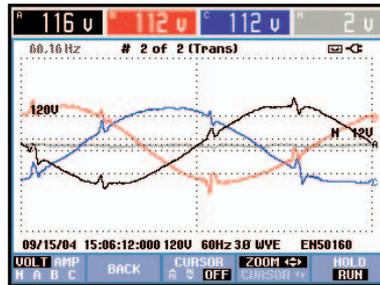
Sample screen.

The team switched to the analyzer's Transients function, so they could see transients as fast as 5 microseconds, started recording and conducted the generator test. When the breaker tripped this time, a transient was clearly evident.

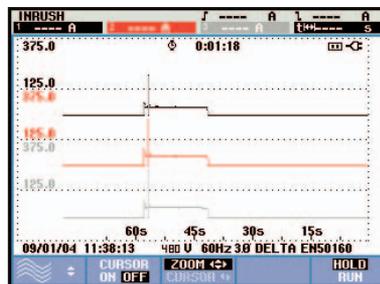
They selected the Inrush Currents function on the analyzer and reviewed the current levels for all the loads managed by the emergency power system. The technicians did see an inrush event. The inrush magnitude was within the equipment specifications ... but why was the inrush event occurring when the system was already operational?

For some reason, the elevator system wasn't sensing the power fault condition. So, every time emergency power was reapplied, the elevator system started to perform a normal start-up – and that much inrush and start-up current on top of normal operations exceeded the rating of the power emergency protection circuit breaker.

A simple adjustment to the elevator power fault sensing circuit allowed the new system to properly perform the individual elevator car power failure procedure. In the process, facilities verified the protection circuit breaker settings and adjusted them back to the proper set points.
