Electrical inspections using thermal imaging

Application Note

By Jim White, Shermco Industries, for Fluke

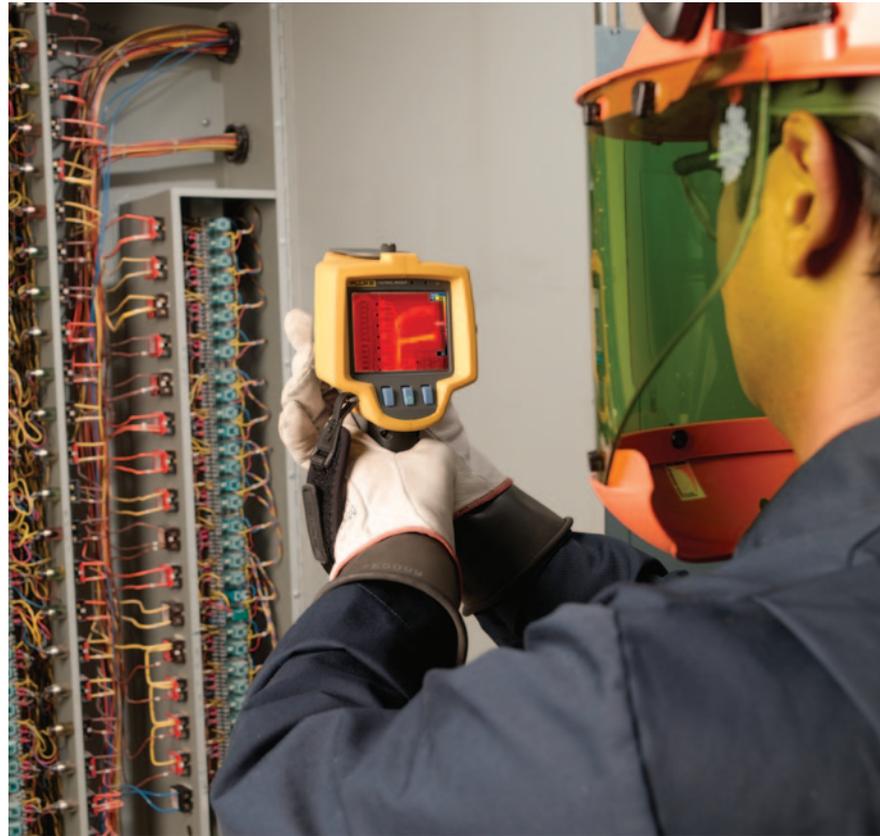
Inspection of lighting control circuits with a Fluke Ti25 Thermal Imager and appropriate PPE.

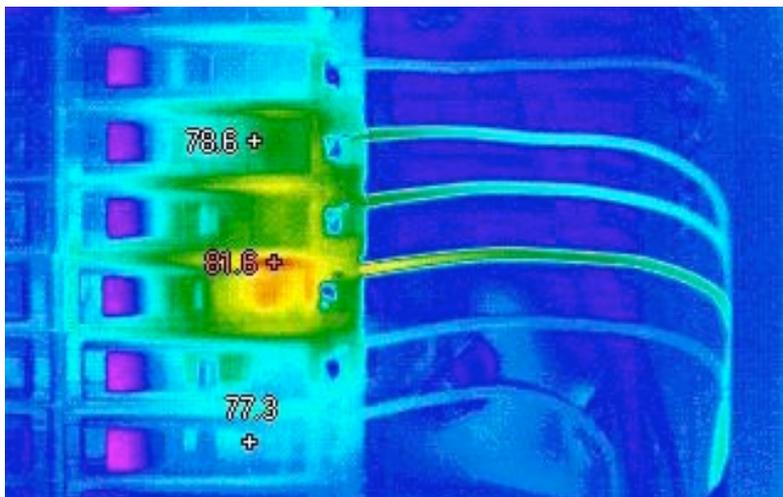
Figure 1. Thermal inspection of a molded-case circuit breaker terminal.

Infrared thermal inspections can find this type of defect reliably. Figure 1 is an example of a molded-case circuit breaker terminal that shows severe overheating. The tested spot is marked by a “cross” and the temperature difference is over 110 °C. NETA (the InterNational Electrical Testing Association) provides industry-accepted recommendations for action points for thermal imaging (see page 3).

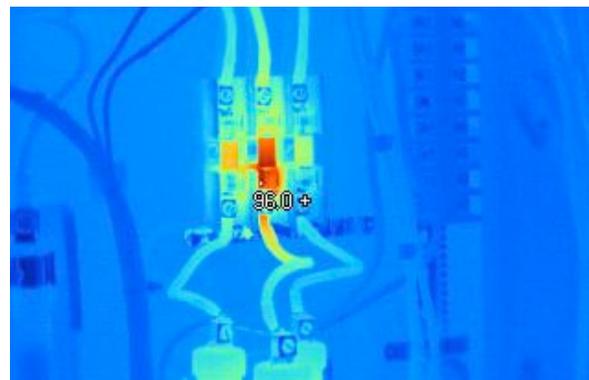
Figure 3. Improper contact pressure.

Figure 3 shows a switch with high contact resistance. Later inspection found that the operating mechanism was experiencing mechanical binding. This fairly common defect can sometime weld the contacts together (Figure 4). Both situations are extremely hazardous. An overheating contact assembly (Figure 3) could cause a fire or fail when opened or closed, and a welded contact (Figure 4) can't open. If the welded phase won't clear during fault conditions, it could result in an explosion. During normal operation, the welded phase would remain energized.
