Three phase motor failure

Application Note

Power Quality Case Study

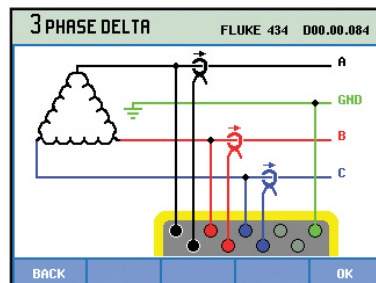
Fig. 1 Three phase Delta

The consultant connected his Fluke 434 three-phase hand-held power quality analyzer to the circuit supplying energy to the motor and pushed the View Config button. The diagram confirmed that his connections were proper and that the power type was three-phase Delta (Fig. 1).

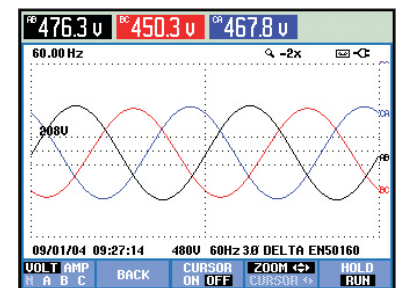
Fig. 2 Unbalance voltage wave

From there, he pushed the Scope button and looked at waveforms and numeric values for all three phases. Judging by the differences between the magnitudes at the top of the screen, there appeared to be a balance problem between the phases (Fig. 2).

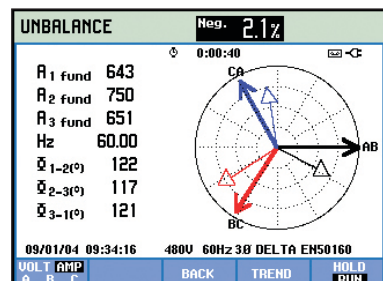
Fig. 4 Unbalanced phaser amp

Switching to the Unbalance screen, he checked the voltage and current values as well as the phase diagram, to see if the motor was operating within acceptable limits (Fig. 4-6).

From his unbalance measurements, he could see that an unbalance was causing an excessively large phase current value. He checked the motor specifications and confirmed that phase current exceeded the motor's FLA (Full Load Amperage) rating. Looking at the data for all three phases, he traced the current unbalance to excessive loading on one voltage phase.

To resolve the situation, the consultant balanced the internal single-phase loads between the three phases, reducing the overall voltage unbalance and consequently, the current unbalance at the motor. This also reduced the elevated phase current value and operating temperature at the motor.

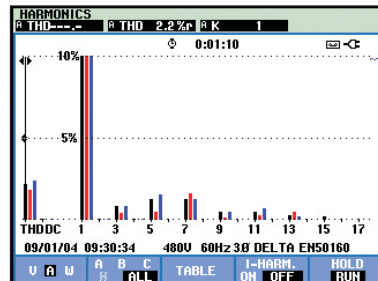
Fig. 7 Harmonics

Lastly, to cover his bases, he selected Harmonics from the menu to make sure frequencies weren't contributing to the problem (Fig. 7 & 8).

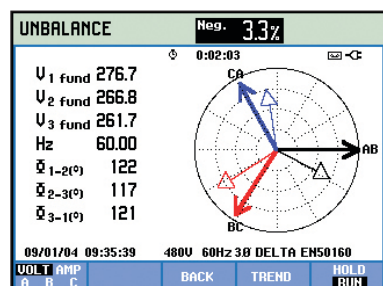
Fig. 5 Unbalanced phaser volt

were connected to the same phase. That last new equipment installation caused such a significant power system voltage unbalance that it created a current unbalance at the motor, increasing the operating temperature of the conductors and motor windings to beyond the limits.

The consultant traced the voltage unbalance to a set of equipment installed three years ago. It turned out that all of the internal single-phase loads
