Lighting the way at Minneapolis-St. Paul International Airport

Technology at Work

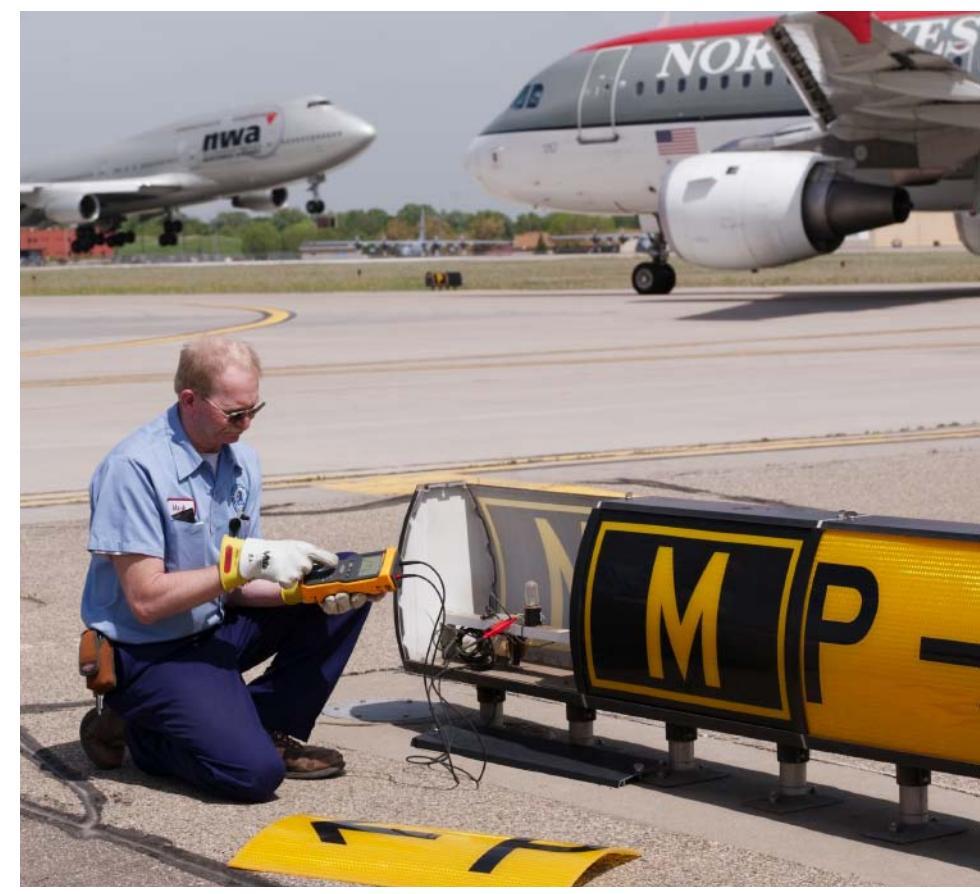
MSP electrical foreman, Mark Temple, uses a Fluke 1520 MegOhmMeter to locate trouble spots.

Bob Litke's crew uses the 1520 for troubleshooting failures and performing preventive maintenance. It's especially key for locating trouble spots. "Our process in locating a problem varies with how many lights are out," says Litke, "Often, we must use the process of elimination to locate it. Technicians test the cable on each side of the failure at 1000 V for 2 minutes minimum. If resistance holds or goes up we eliminate that area of the run. The process continues until the degraded wires are located."

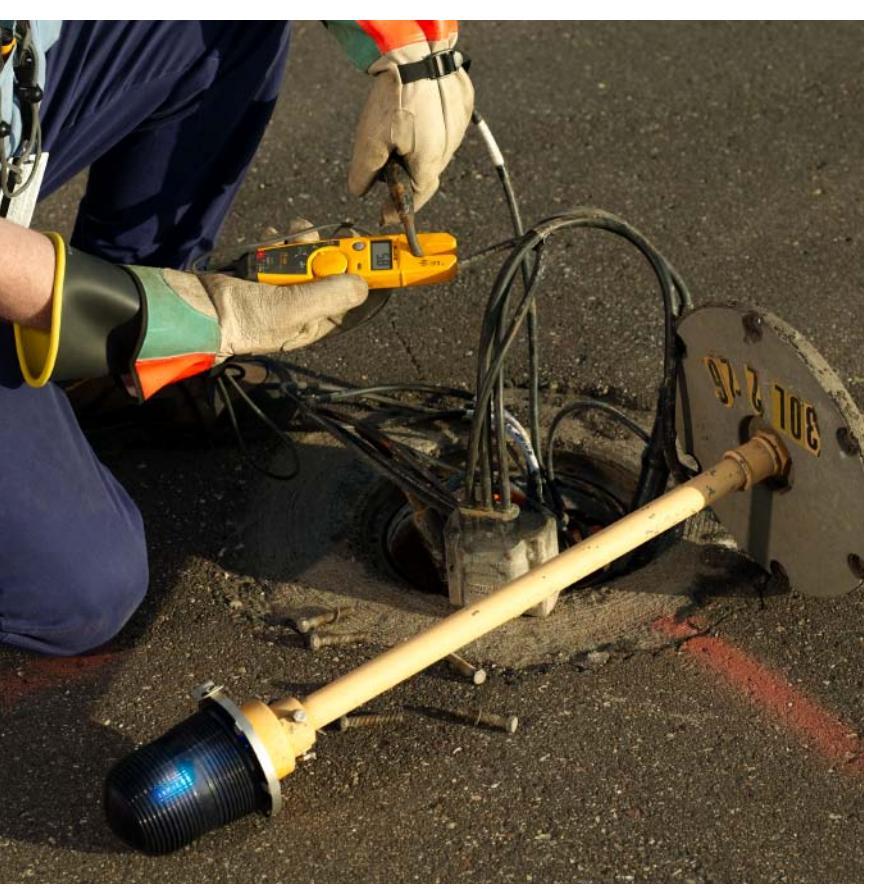
Using a Fluke T5-1000 electrical tester to check current.

Once Litke's crew locates a damaged wire, they must repair it as soon as possible. But given 24/7 airport operations, "serious" maintenance has to be done at slow times, often at night when fewer flight operations are scheduled. Then, they use another Fluke tool, the T5 Electrical Tester, to check any "suspected" cable. Once they confirm that there's no power in that portion of the circuit, they can remove wires located in conduits, pull new ones and splice them in place. In other cases, they dig up buried cable and replace or repair it. At the end of every repair, the crew checks the new wiring with the 1520.
